Flooded Cable/Connector Water Blocking and Reterminating at Sea

By Robert Lindberg, President, RELTEK, LLC

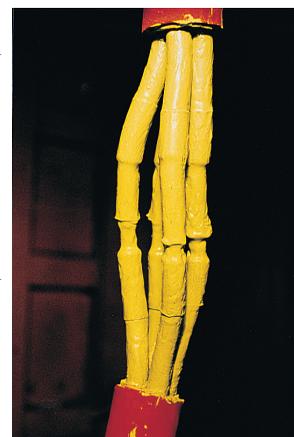
wrong. Low insulation was measured between the ground lead and one of the hot lines of a three phase system. Investigation showed the multi-motor fresh water, pressure compensated cooling system was under positive pressure at all times. Strangely enough, the ground wire was terminated inside the water cooling system using self-vulcanizing tape for the terminal seal which eventually failed. Water was then forced through the ground wire, into the connector, and back up the entire cable. Water failure was from

Inner assembly of the splice that was successful in blocking water from coming through the ground wire

ever was available onboard ship to withstand 1,250 meters operating depth outside and positive hydro pressure inside. The new design was successful using BONDiT™ A-3 primer for all the substrates and B-1 potting and adhesive compound for sealing and mechanical stability. The polyurethane overmold was final curing while mounted on the hammer, waiting for deployment in a matter of hours. The new termination system operated flawlessly while withstanding operations to 1,250 meters, mounted on a pile driver hammering sixteen 405 feet piles into the ocean floor. Menck was able to go online, operate and complete the job on schedule by implementing the BONDiT™ A-3 and B-1 cable termination system.

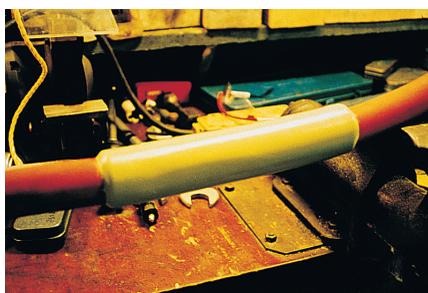
Splice fully potted, without polyurethane overmold, but capable of full immersion

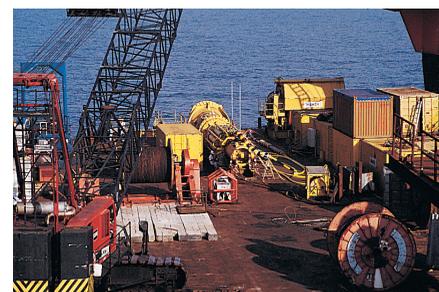
Polyurethane overmolded assembly ready for mounting on the "Hammer"
